History in the making: fast, lasting solutions for heritage-listed bridge

Client: Transport for NSW

Location: New South Wales

In 2020, Megapoxy solutions were used to help repair and strengthen the top chord of Crankies Plain Bridge over Coolumbooka River. Still a high-traffic crossing, this heritage-listed structure was completed in 1892 – and is one of only seven McDonald timber truss road bridges remaining in the state.

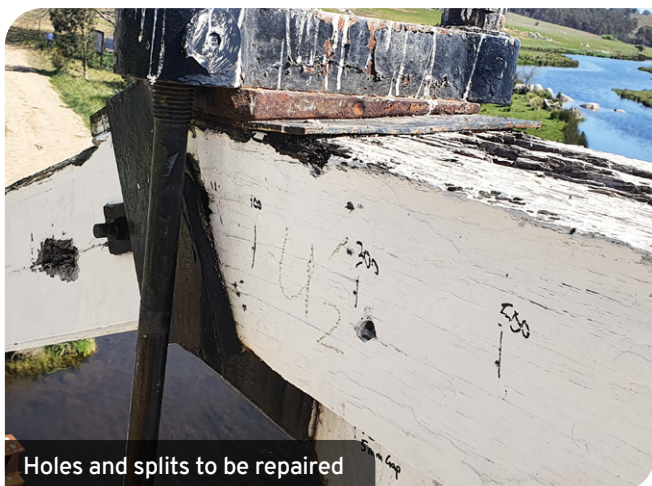
Holes and splits to be repaired

- The team first removed all damaged and rotted timber.
- They sanded and removed paint from the top chord, and sealed all large holes and splits with Megapoxy 69, our high-strength epoxy adhesive gel with exceptional and sustained impact resistance.
- All small holes and splits were then sealed by painting on Megapoxy MC2 (in white), a maintenance coating with fast work time, proven durability and resistance to corrosion, impacts and scrapes.
- Finally, pouring holes were drilled along the top chord into the void to be filled.
- Megapoxy 108 mixed with a fine aggregate and pour into the splits and prepared holes. This created a rapid-set liquid epoxy mortar to create high compressive and impact strength, fast.

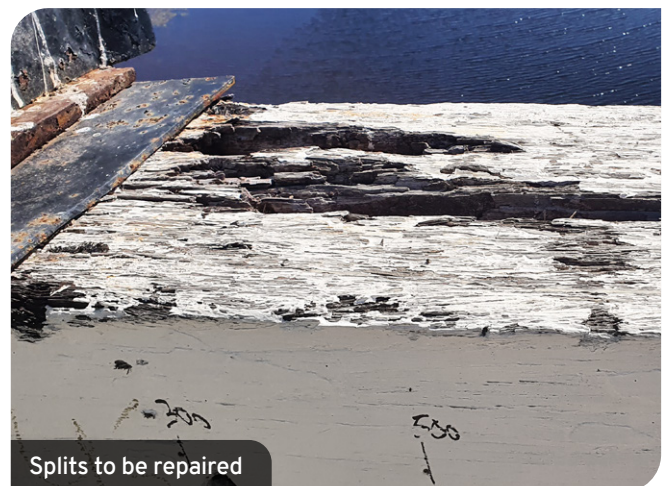
Splits to be repaired

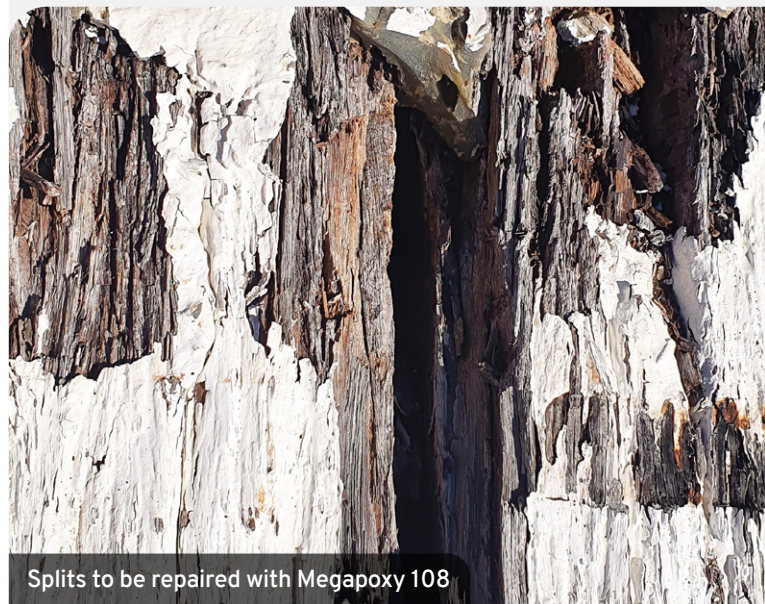
Splits to be repaired with Megapoxy 108
