Stacks on: powerful bonds for upmarket apartment facade

Client: DNA Stone

Location: Killara, New South Wales

Remove an apartment building's deteriorating stackstone façade and replace with fresh stackstone – using an epoxy paste adhesive to bond the stones to a pre-cast concrete wall.

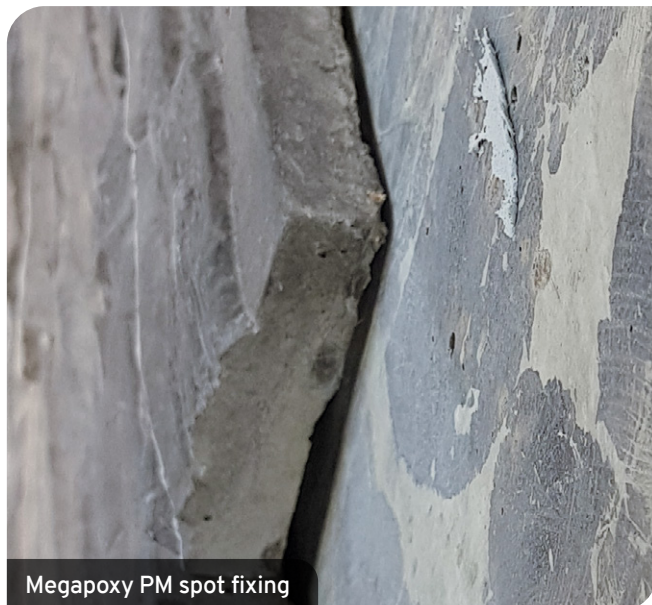
Megapoxy PM spot fixing

- The team removed all existing tile adhesive, by grinding back to concrete.
- They removed dust, damaged concrete and other debris from the wall surface.
- The new stackstone was secured in place using an easy spot-fixing technique.
- This simply involved applying three spots of Megapoxy PM, evenly placed across the back of the stackstone panel, and securing it to the wall.

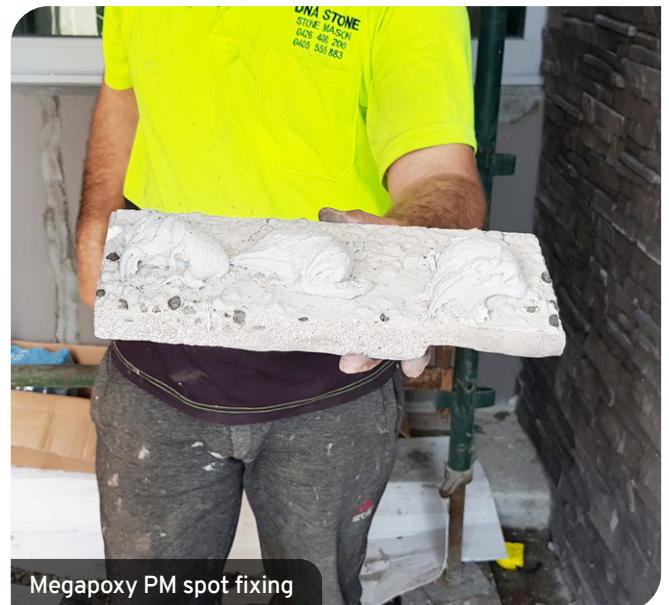
Megapoxy PM spot fixing

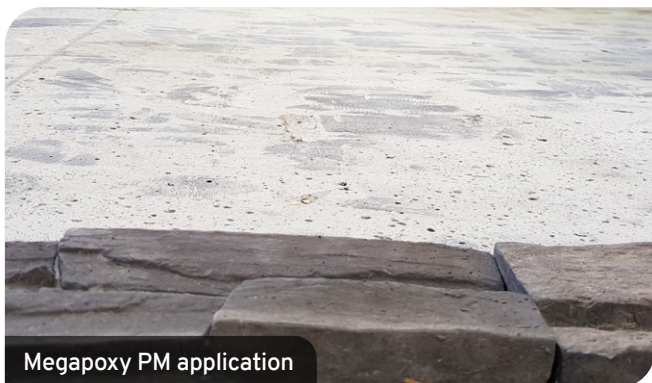
Megapoxy PM application

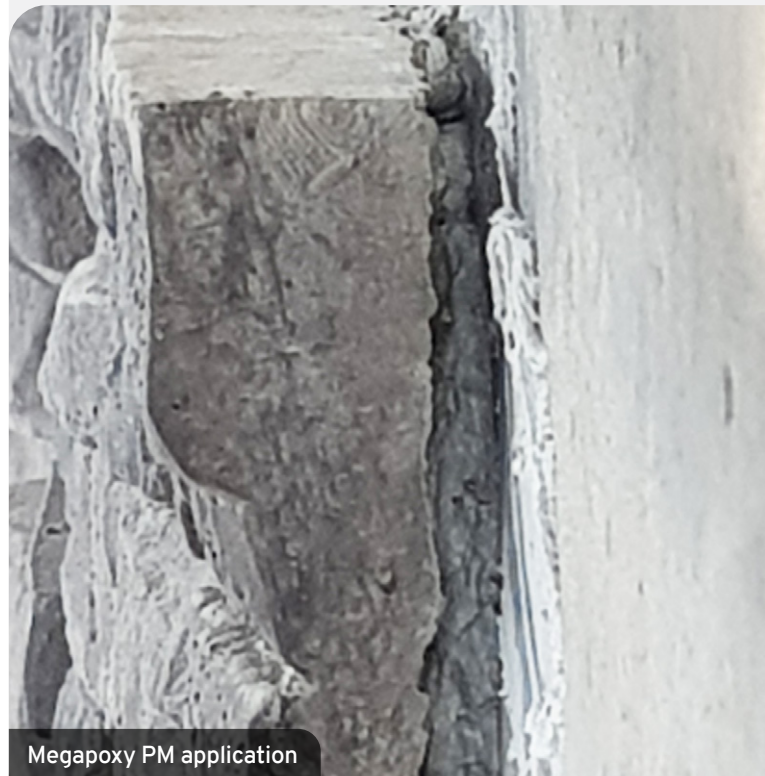
Megapoxy PM application
